December 7, 2016

**Re: 26 Caroline Street Investigation
Saratoga Springs, New York
Ryan Biggs | Clark Davis Project 11584**

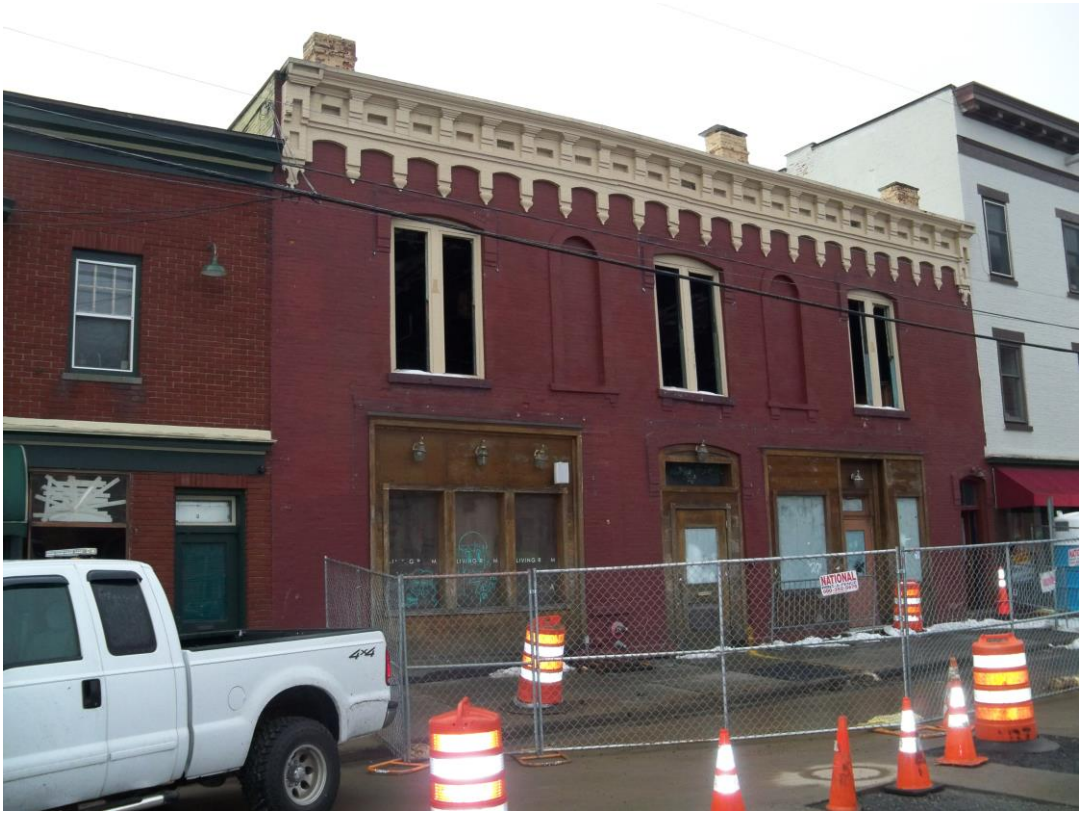
4. The front masonry facade does not appear to have been damaged or displaced by the fire; however, there are some pre-existing conditions consisting of minor displacements and bulges in the masonry. However, further collapse of the building framing could compromise this wall.

Photograph 1 - front masonry façade looking southwest.

The front masonry facade appears to be stable with no signs of major structural distress; however, with the potential additional collapse of the floor and roof framing, this could cause damage and/or movements of the facade with possible collapse of the wall. With regard to saving the front facade, in my opinion this is structurally feasible. However, design of a shoring and lateral stabilization system would need to be completed and implemented immediately.

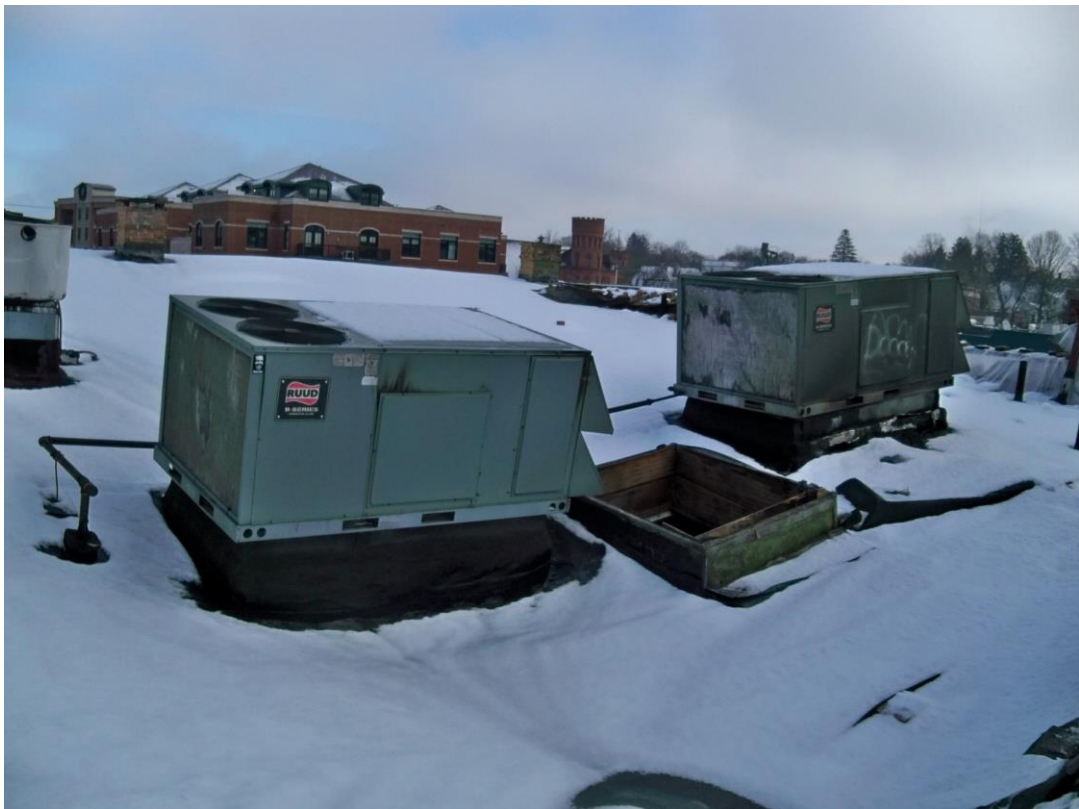
2. There are two large rooftop HVAC units on the roof in the area of the partial collapse. The weight of these units could cause further collapse of the building framing. See Photograph 2.

Photograph 2 - portion of partially collapsed roof where existing HVAC units are present.

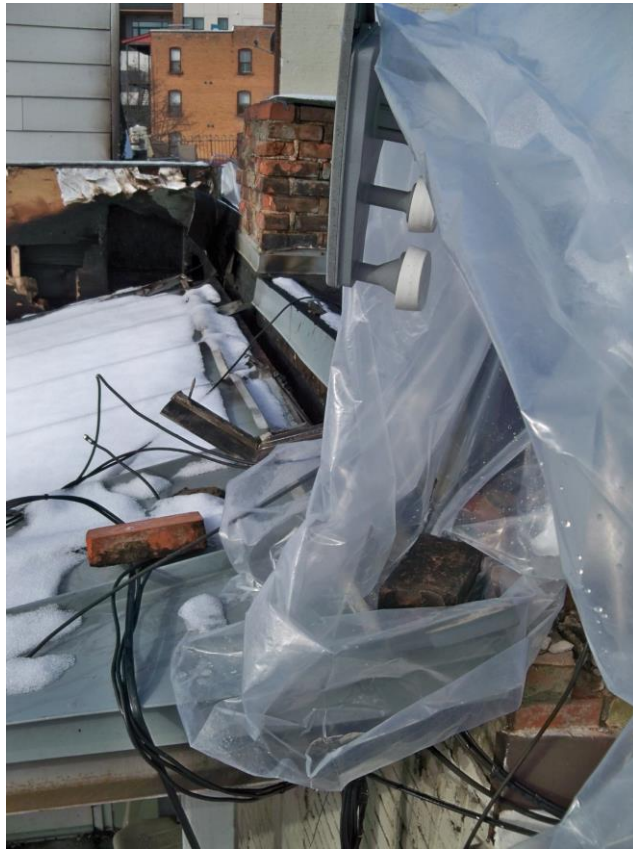
3. The rear masonry wall has displaced laterally into the building (towards the north), which appears to be due to the collapsed framing. This area is shown in Photographs 3, 4, and 5. A complete review of this wall could not be made.

Photograph 3 - separation gap between rear building wall and rear stairwell.

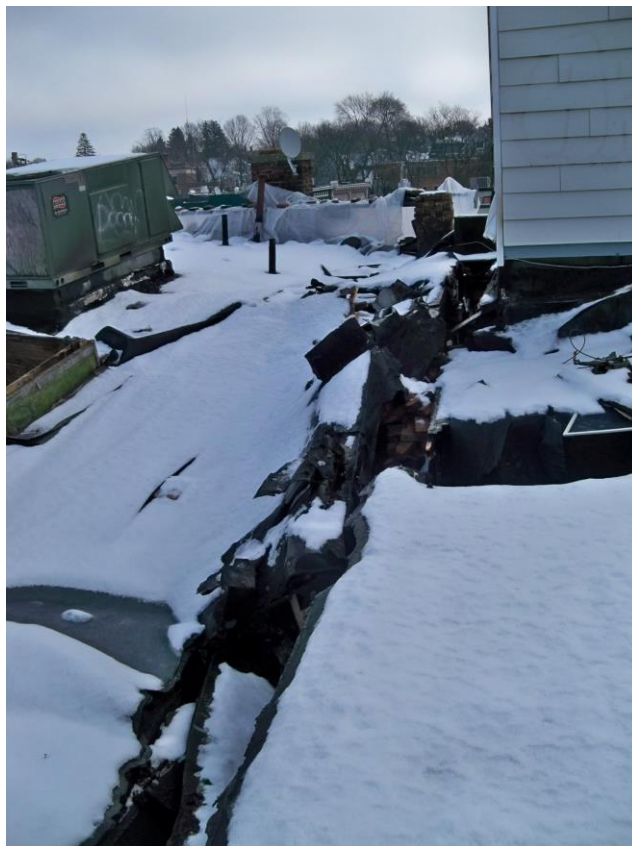
Photograph 4 - area of partial roof collapse and lateral displacement between main building and rear additions.

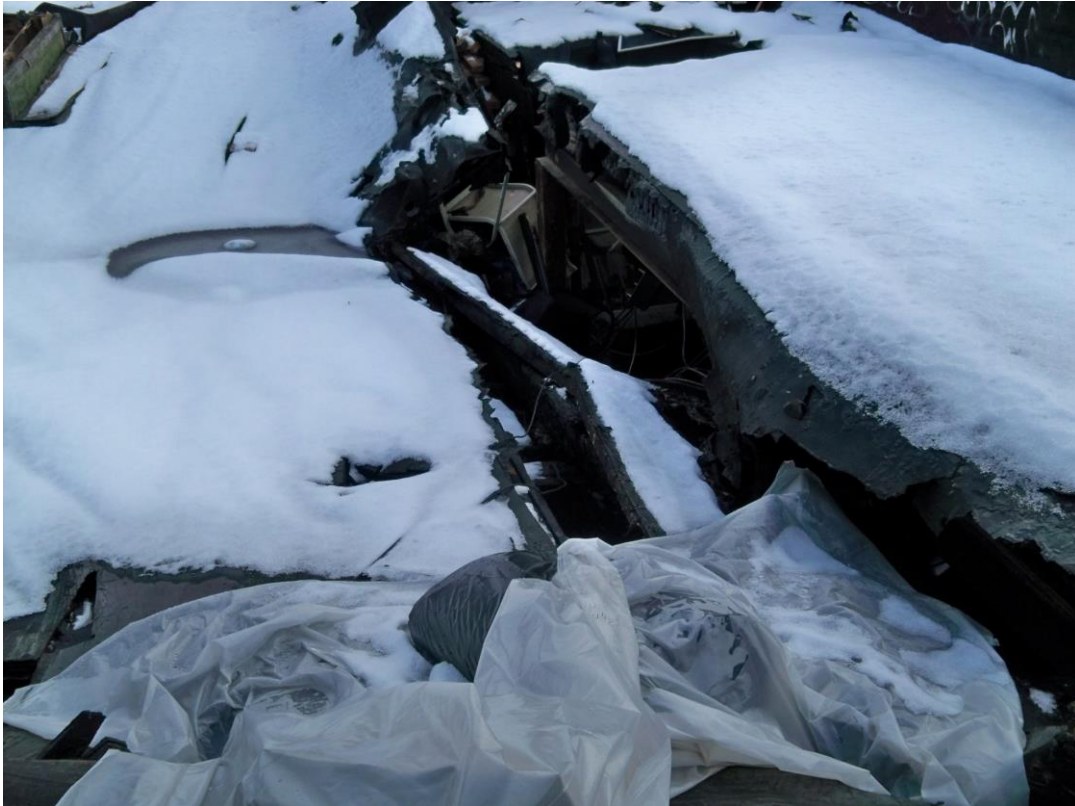
Photograph 5 - area of partial roof collapse and lateral displacement between main building and rear additions.

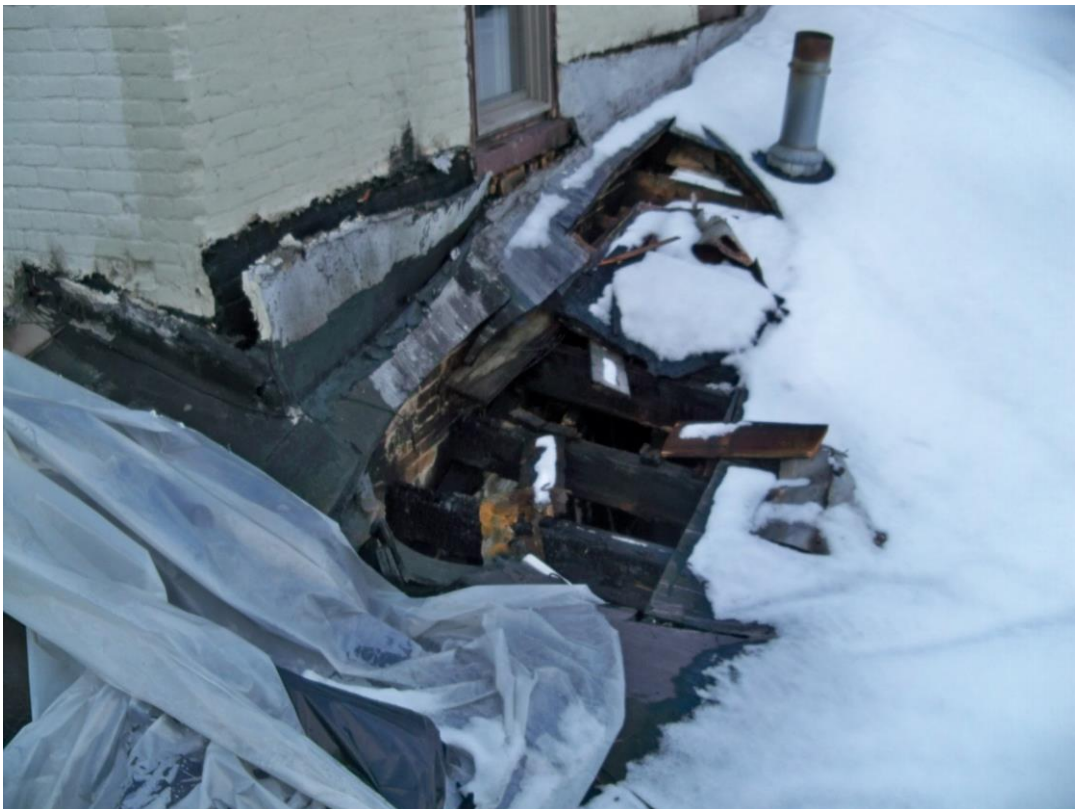
Photograph 6 - area of fire damaged roof and partial collapse at southwest corner of building.

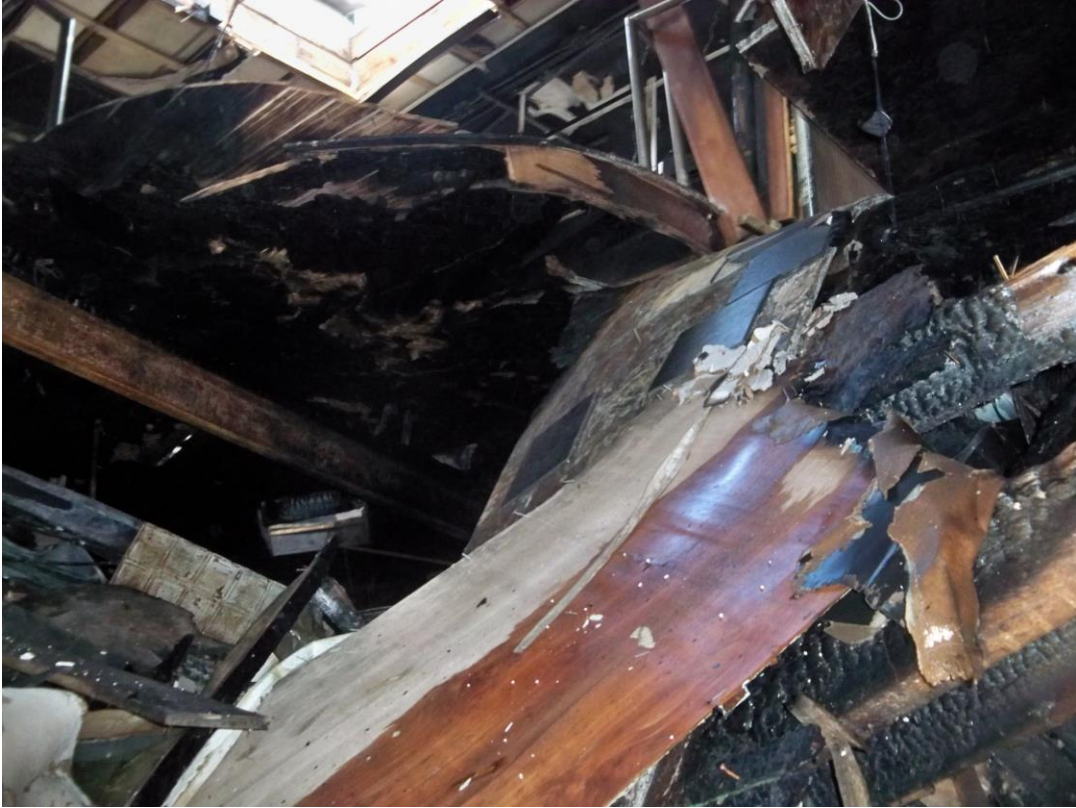
1. The fire has severely damaged the wood floor and roof framing with portions of the framing collapsed in the middle and rear portions of the building.

Photograph 7 - area of second-floor collapse within the building.

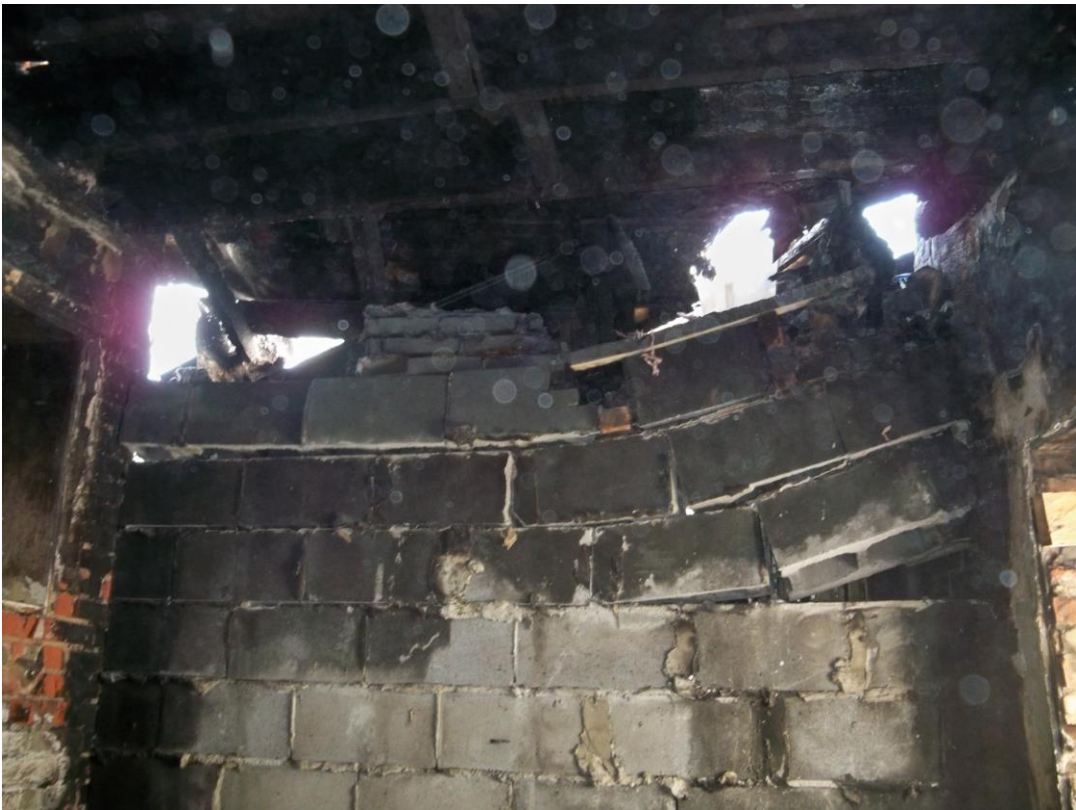
7. At the rear southwest corner of the building, a masonry wall that appears to be part of the addition has partially collapsed. This was observed from within 24 Caroline Street. This area is shown in Photograph 8.
8. A portion of the masonry parapet wall on the east side where it abuts 30 Caroline Street has collapsed onto the roof. Currently this area has been covered with plastic for weather protection.
9. Within the first-floor space near the front of the building, there were areas where the second floor was supported by temporary shoring posts. It was reported that the building was under renovations prior to the fire.

Photograph 8 - partial wall collapse at southwest corner of building.
