Saratoga Springs Preservation Foundation
Saratoga Race Course Cultural Resource Inventory
Phase 3
Buildings

Saratoga Race Course Structure Inventory Form

Millionaire Row
ARCHITECTURAL EXISTING CONDITIONS

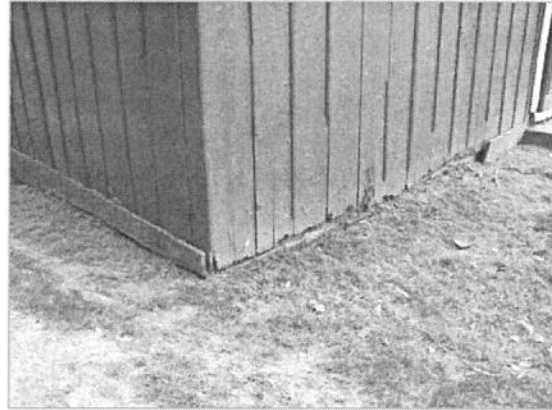
For the Type G dorms, they are generally aligned along the east ends of the barns and directly next to the service road with the grade sloping away toward the barns. Generally a portion of their base and skirt boards are in contact with the grade which is causing some rot. This condition has been exacerbated by the effects of the water spray truck that wets down the dirt road regularly. Along the east side and portions of the gable ends, the lower part of the vertical boards and battens are very weathered with peeling paint or rotted completely away. High grade at the base is a common issue with the Type C buildings as well, resulting in rotted sill plates and lower courses of clapboards.

Rotted & missing skirt board and battens at Bunkhouse #52

- Retain, repair and upgrade as necessary all converted Kitchen facilities that currently function as bunkhouses in order to maintain the small scale and intimate charm of historic Millionaire Row. Many of these structures were intended to be raised and set on piers, however over time the grade has been raised causing wood decay. The buildings should be carefully lifted and raised high on their piers to allow for repairs to sill plate, skirt board or lower courses of clapboards.

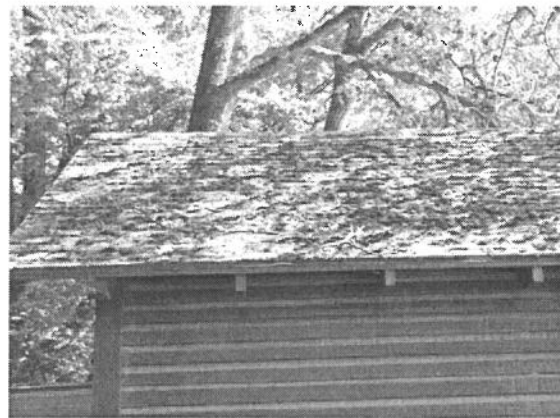
Asphalt roof on BH49 is covered with moss on north slope.

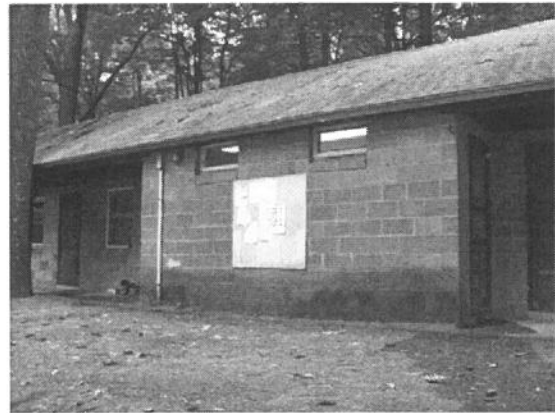
debris that accumulates on these asphalt roofs, leading to more deterioration. These bunkhouses each have a central bathroom block between rooms #6 and #7 which includes multiple showers, sinks, toilets, and urinals. Along the front walls of each of these bathroom blocks the walls are damp and heavily covered with moss due the absence of gutters to direct the roof water away and the shaded environment. The plywood ceilings in the porch are covered in mold or mildew. In general, the building elements are showing wear after 50-55 years of service.

Front wall of central bathroom of Bunkhouse #54 with thick moss coverage at lower courses from roof water splash back.

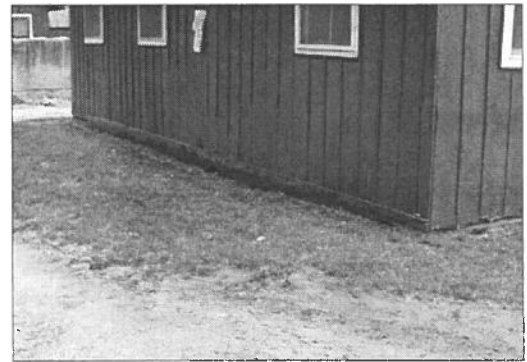
BH57 exhibits the wood deterioration problem common of wood-clad buildings located adjacent to dirt roads where large water spray truck regularly wets the bottom half of the building. Note the rotted or missing skirt boards and battens as a result of this accelerated rot.

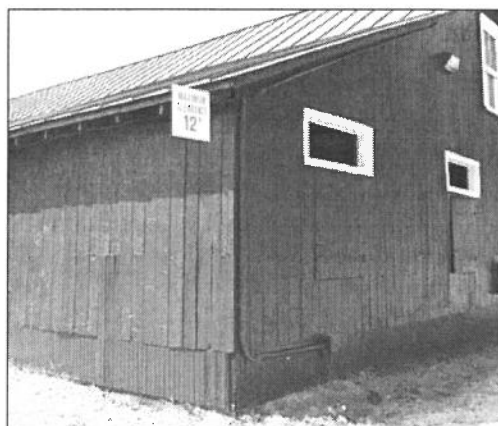
Another maintenance effort that has had a negative impact was the 1968 repair of the lower 2' of vertical siding. Naturally vertical boards that were allowed to come into contact with the moist ground or high grade would absorb moisture into the end grain of the boards, resulting in wood rot. While this was likely a design fault of the original barn construction, one method that has been employed on countless barns, residences and support structures particularly where vertical board and batten or tongue & groove boards are used is to terminate the vertical cladding on a horizontal skirt board which covers the sill plate. The 1968 repair work on barns 27, 28, 30, 31, and 33 simply removed the lower 2' of board siding and replaced it with new vertical boards of different sizes instead of installing a skirt board. This change in materials is very noticeable and hasn't solved the problem of end grain in contact with the ground. Ironically there is evidence of an earlier fix of this problem with the installation of 5-6 courses of clapboards at the bottom 2' on buildings that later burned down, yet horizontal boards would have solved the rot issue related to open wood grain.

The 1968 repair of the lower 2' of vertical tongue & groove boards repeated the problem while negatively affecting the appearance of the old barns.

- Ultimately the large problem with the barns is the treatment of the lower 2 feet of the walls. The existing vertical tongue & groove boards that were installed in 1968 or later, should be replaced with a horizontal skirt board or several courses of horizontal boards to prevent further wood decay. In addition, the grade pulled away from the wall, particularly on the north side.

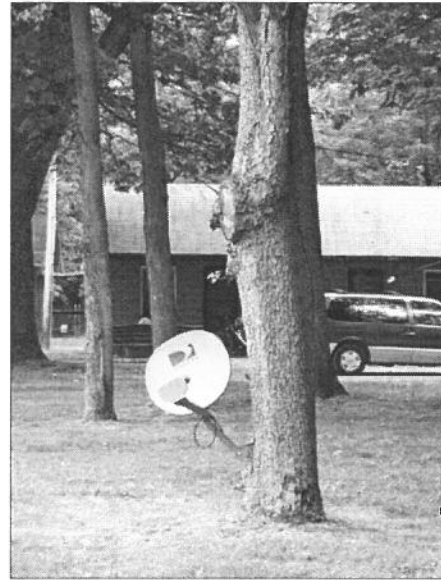
A resident's satellite dish attached to one of the trees in the dormitory area near BH54.

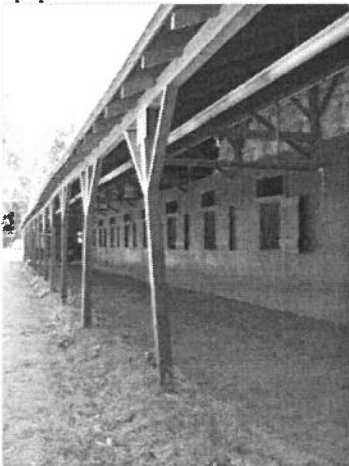
Rear shed row of Barn #30 illustrating shuttered screen windows and upper transom. Note also the shed post that is out of plumb.

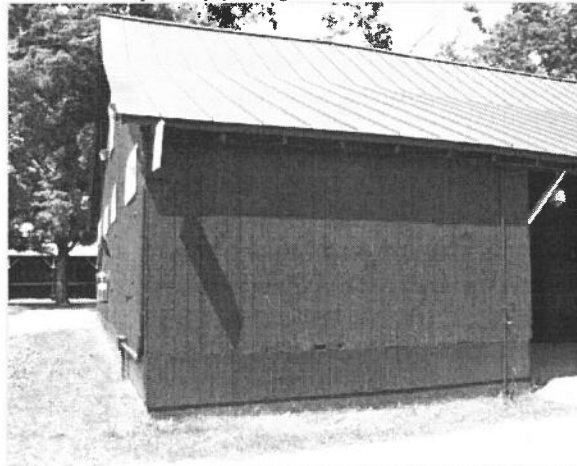
Typical condition of lower walls where new vertical boards were installed at lower 2 feet. Note also the Kynar finished metal roof.

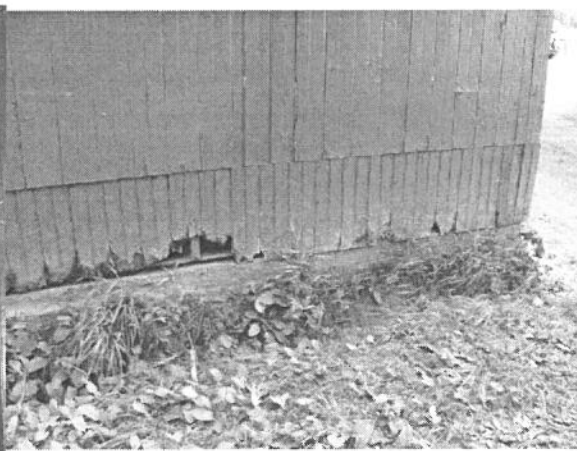
View of north-facing side wall at west end gable where typical case of rotted boards and moss exist. (Barn #31)

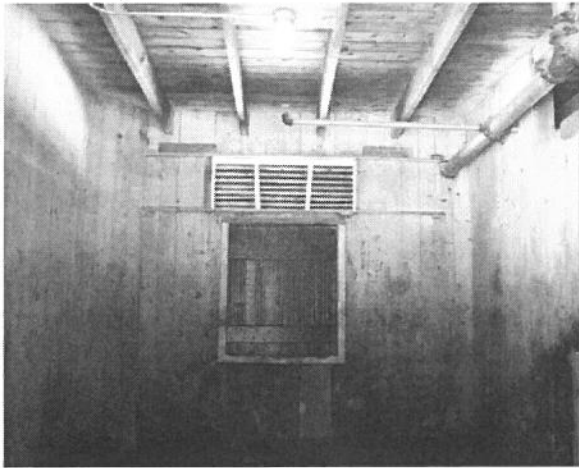
View to interior of stall in Barn #27 showing rear wall with missing sliding transom windows.

- There are not a large number of windows in the barns, however, the gable end windows and sliding transom windows are important elements of the original design. Many of the loft level gable end windows have not been maintained or repaired in recent years and they require some level of repair or restoration. The sash should be removed to a shop so that their frames can be repaired, repainted and sash cords replaced. The sash should be stripped of remaining paint, strengthened at the mortise and tenon joinery, glass reinstalled and glazed and the sash fully primed and painted with oil-based paints before being rehung in their openings. Where transom windows are intact but the glass is covered with paint, the glass should be cleaned. Naturally any broken panes of glass should be replaced.

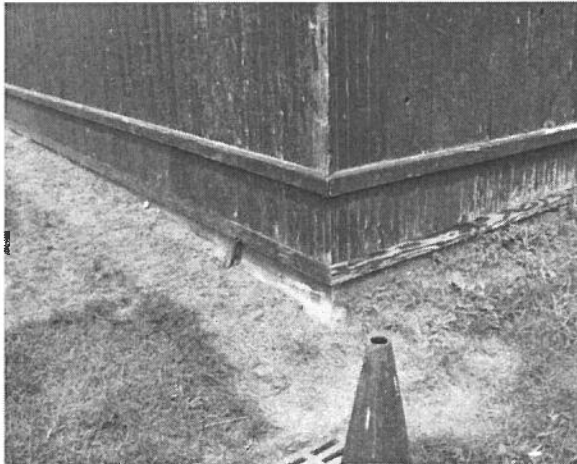
Alternate treatment of transitioning between upper vertical boards and lower vertical boards. Still does not solve problem with open end grain.

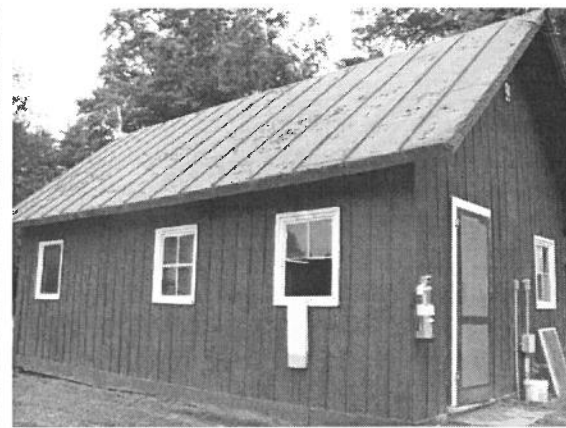
BH59 illustrates some of the worst conditions relating to the metal roofs, the windows and rotted or missing battens.

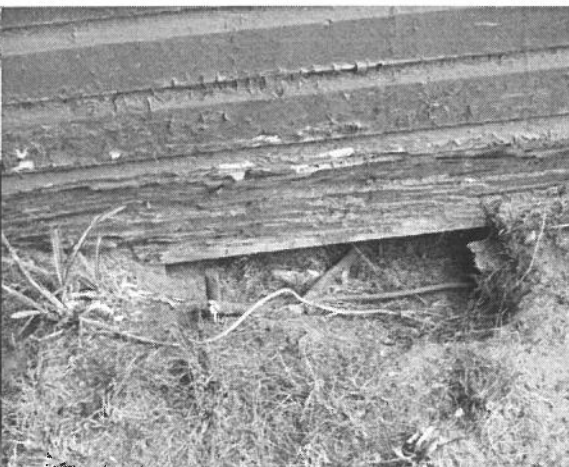
Typical rot at sill and lower clapboard courses on BH53.

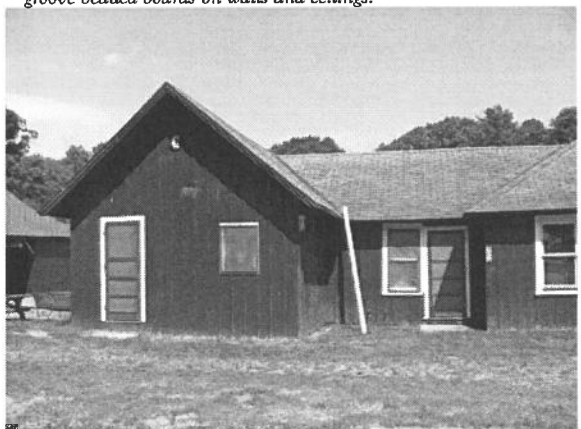
Old residence south of Barn #27 with later additions. Much deferred maintenance.

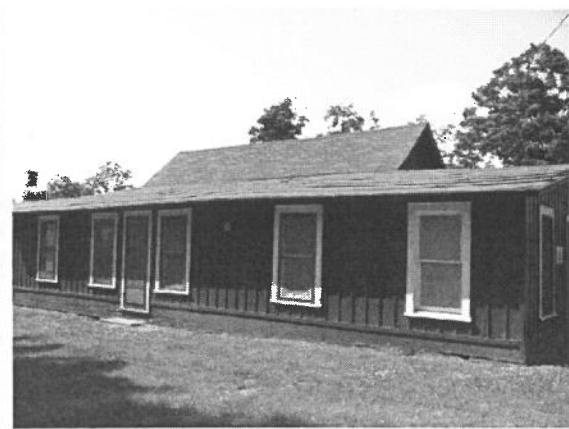
BH43 with L-shaped addition. Addition with its low sloped roof has a rolled asphalt cladding which is lifted and curling.
