THE SECRETARY  
OF THE INTERIOR'S  
**STANDARDS** FOR  
THE TREATMENT  
OF HISTORIC  
PROPERTIES

WITH  
**GUIDELINES** FOR  
PRESERVING,  
REHABILITATING,  
RESTORING &  
RECONSTRUCTING  
HISTORIC  
BUILDINGS

U.S. Department of the Interior  
National Park Service  
Technical Preservation Services

2017

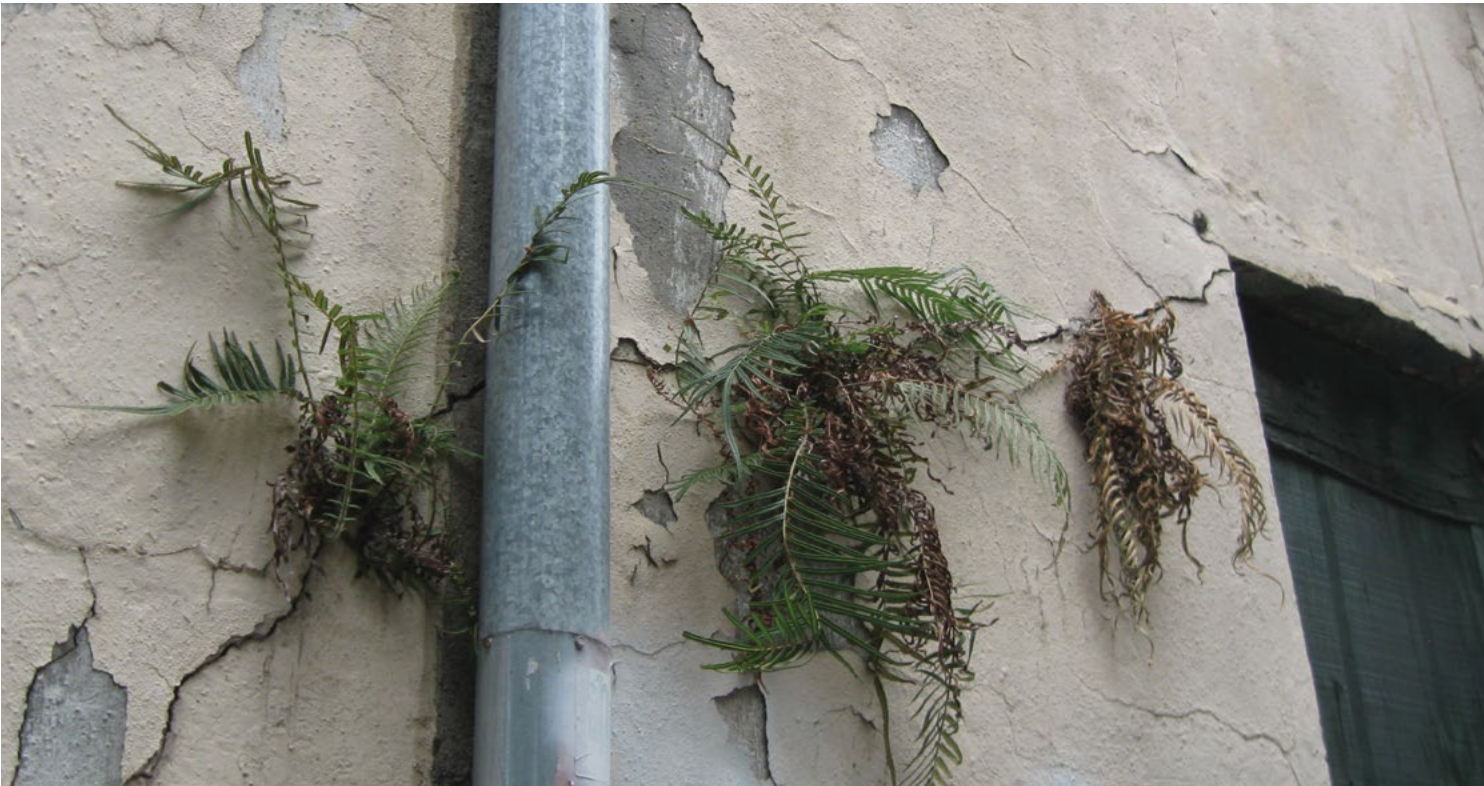
[3] **Not Recommended:** Cracks in the stucco have not been repaired, thereby allowing ferns to grow in the moist substrate which will cause further damage to the masonry.

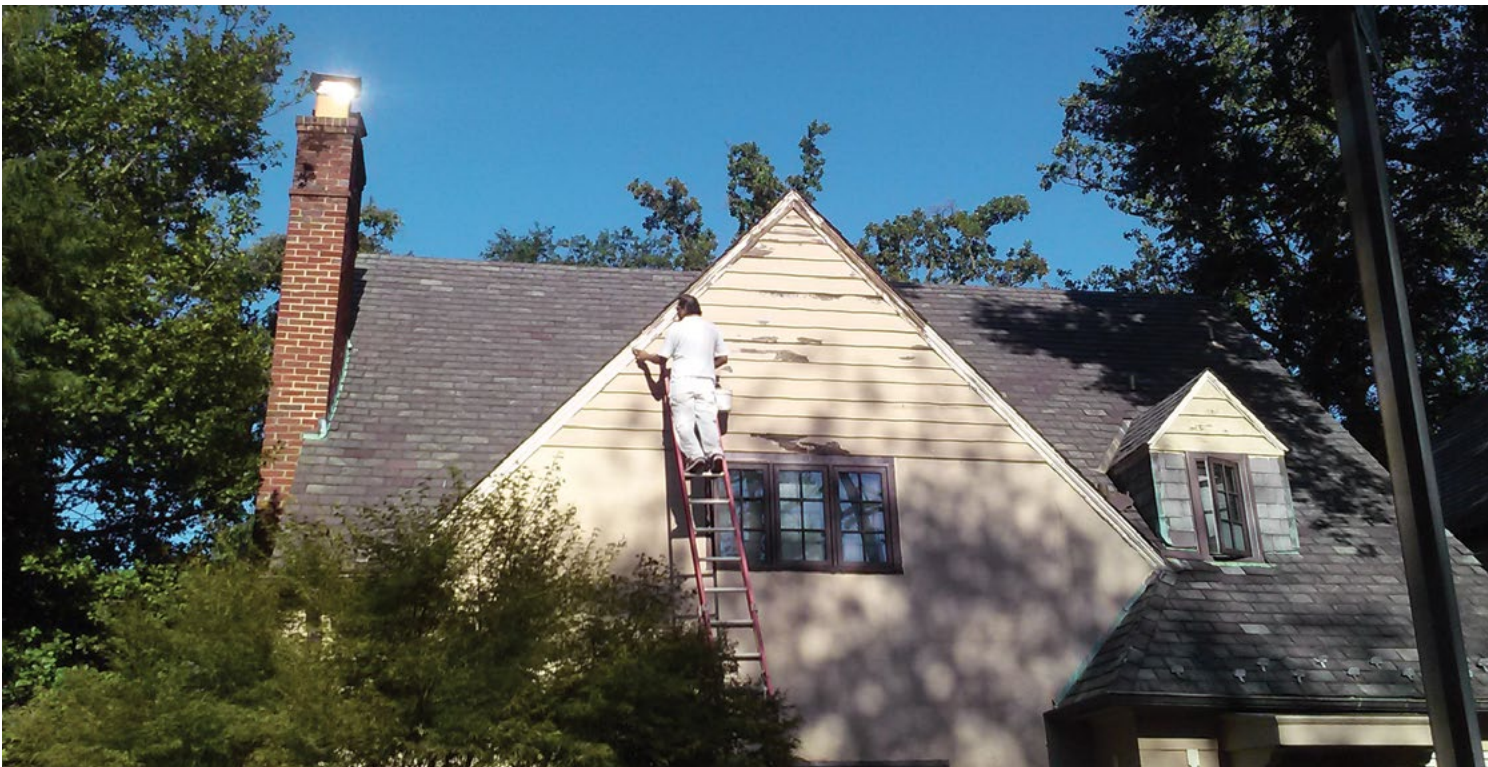
[4] Hand scraping to remove peeling paint from wood siding in preparation for repainting is an important part of regularly-scheduled maintenance.

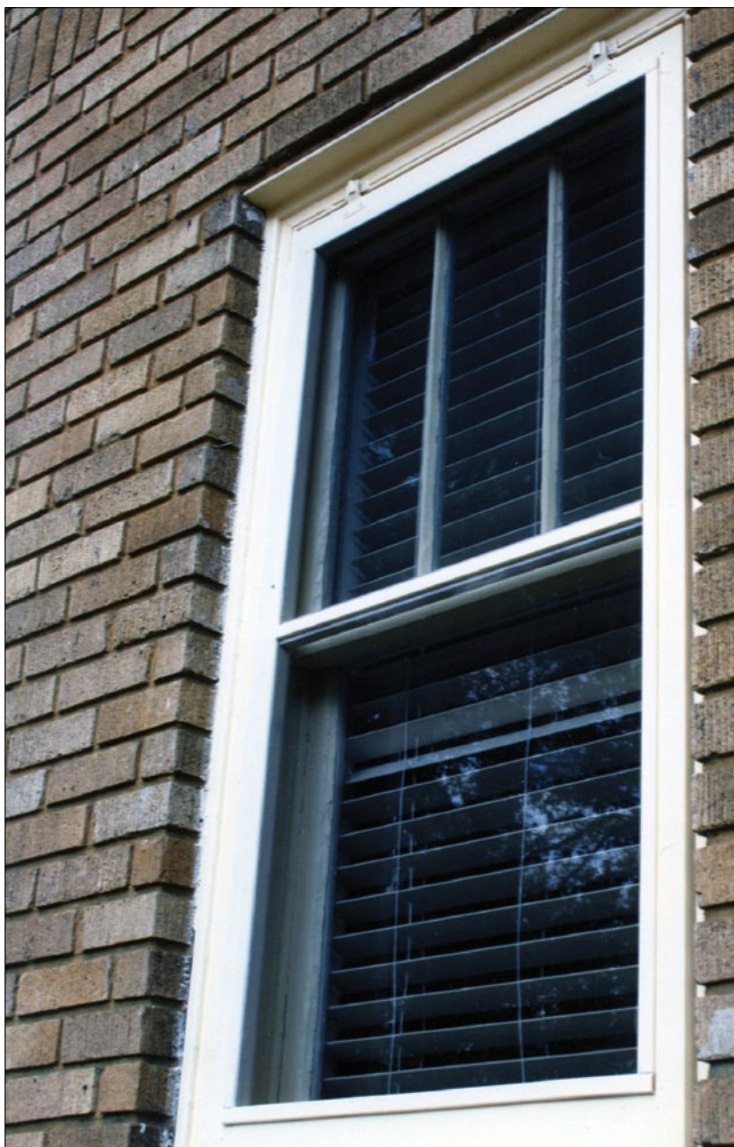
[10] Historic exterior storm windows preserve and help to insulate wood windows.

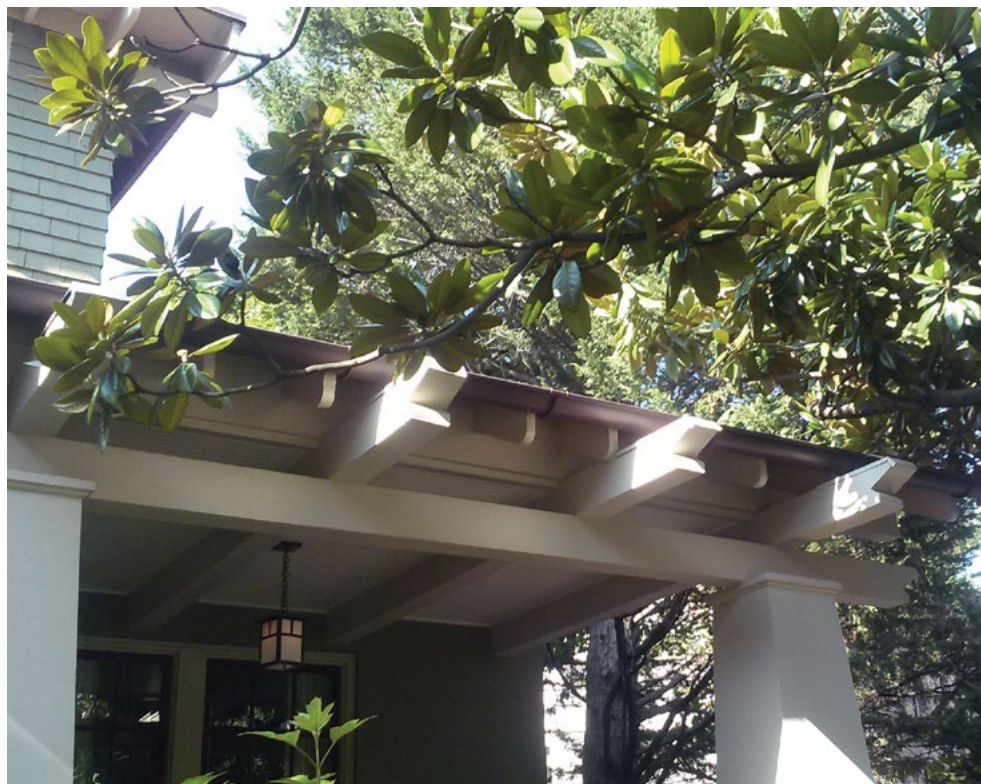
[12] Repair and limited replacement in kind to match deteriorated wood porch features is always a recommended preservation treatment.

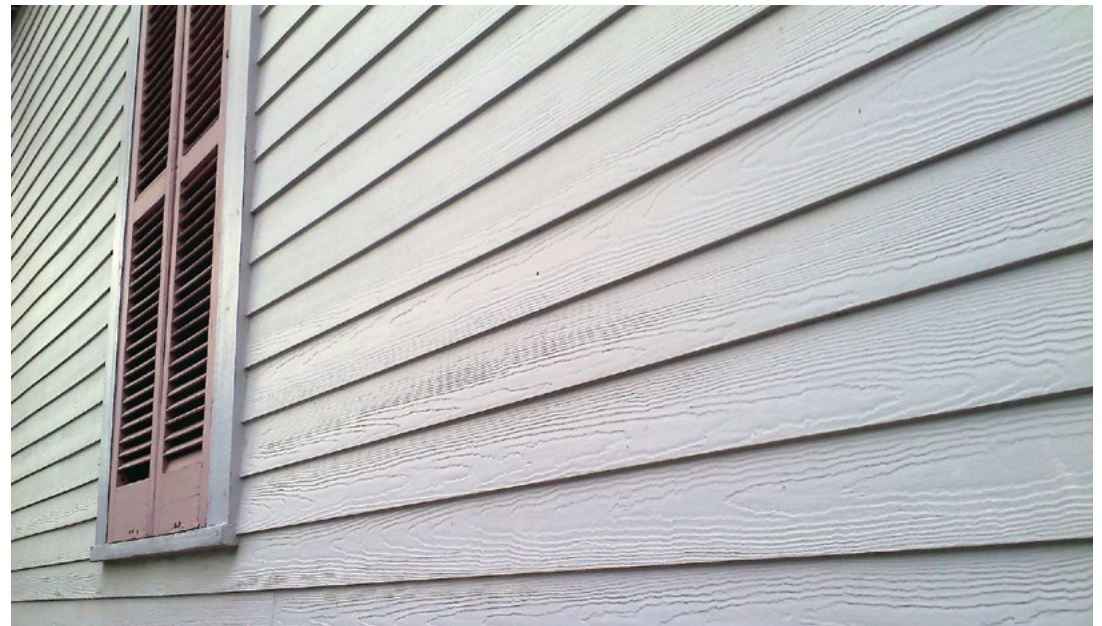
[10] **Not Recommended:** Cementitious siding with a raised wood-grain texture is not an appropriate material to replace historic wood siding, which has a smooth surface when painted.

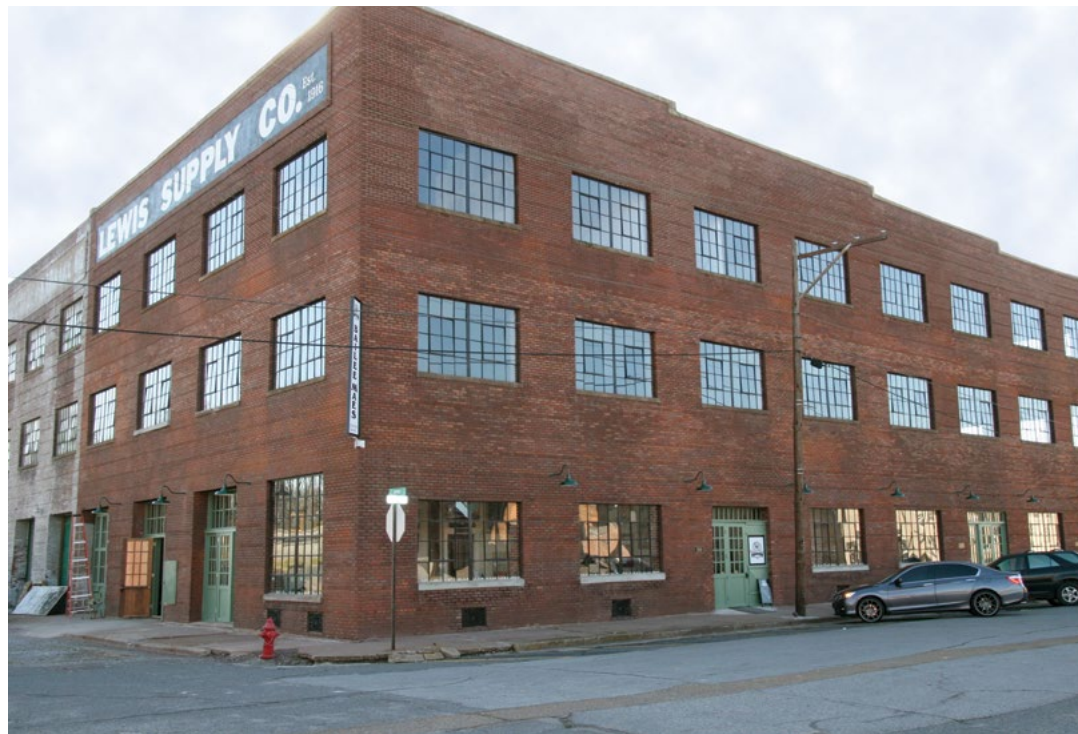
[20 a-d] The original steel windows in this industrial building were successfully repaired as part of the rehabilitation project (left).

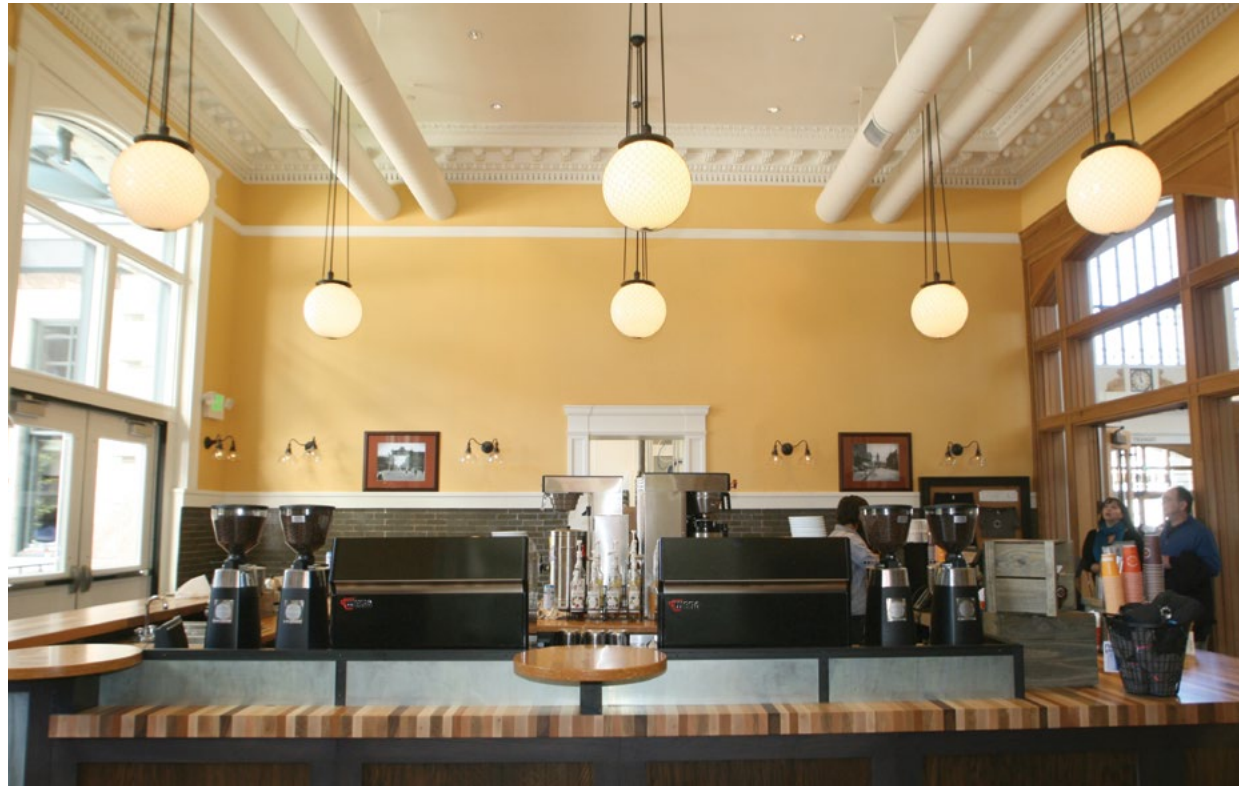
[37] Exposed and painted ducts were appropriately installed here in a retail space in Denver's historic Union Station after considering other options that would have impacted the ceiling height, or damaged or obscured the ornamental plaster crown molding. *Photo: Heritage Consulting Group.*
